Manhole Inspection Summary

Manhole # S41E__003MH

Location Address: **1228 E BALTIMORE ST**

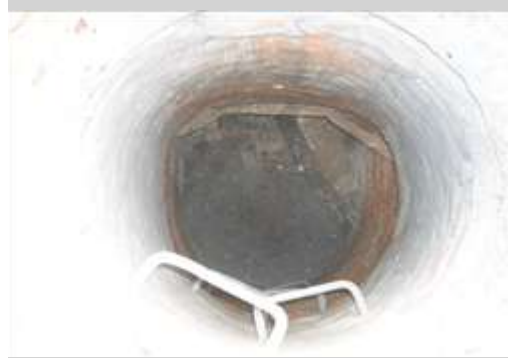
Top View

Comments **OBSERVED THAT MANHOLE LID WAS CRACKED AND SEALED WITHIN FRAME. USED 16LB MAUL TO BREAK THROUGH, AND A SAW TO BREAK SEAL. REMOVED AND REPLACED WITH NEW 24" SANITARY LID. INSPECTION COMPLETED USING MAN ENTRY TO OBTAIN ALL PICTURES.**

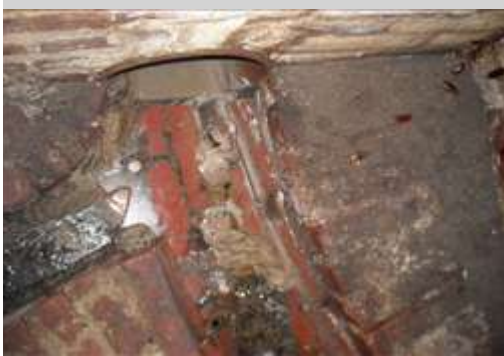
Miscellaneous

TOP VIEW OF CONNECTIONS FROM
INSIDE BARREL UNDER CONCRETE
SLAB

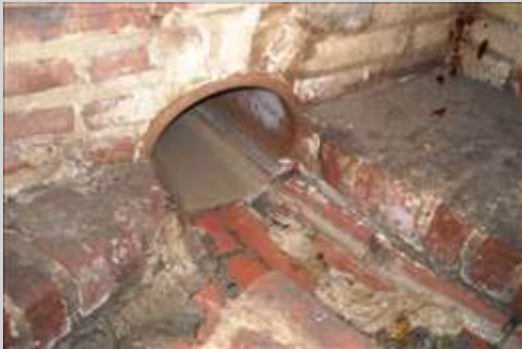
12 O'Clock Outflow

12 in. Circular Gravity Sewer
Pipe Out @ 12 O'Clock

Invert Depth: **12.25** (ft.) Flow Characteristics: **Slow**

Infiltration: **None** Pipe Seal Cond: **Sound**

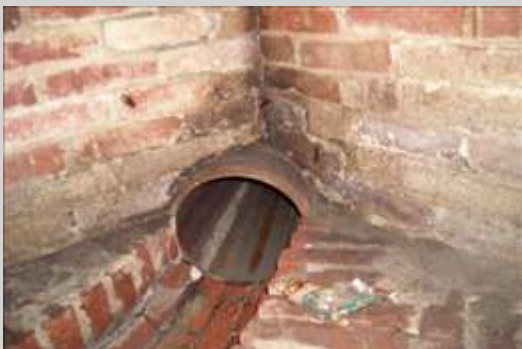
5 O'Clock Inflow

12 in. Circular Gravity Sewer
Pipe In @ 5 O'Clock

Infiltration: **None** Pipe Seal Cond: **Sound**
